COIR GEOTEXTILES

Er. Sheela Mary Cherian, M.Tech, Assistant Executive Engineer.

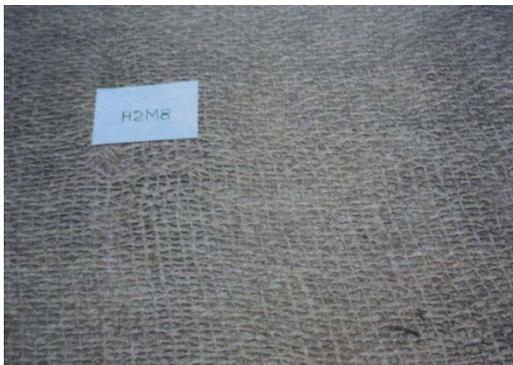
Woven coir netting / Mesh matting used as geotextiles

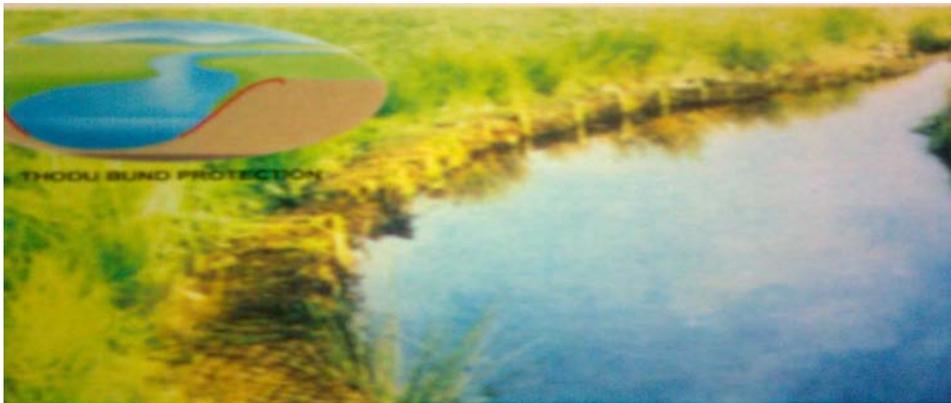
Thodu bund with coir netting

How it is being laid is, first selecting the type of coir geotextiles from site assessment, forming the required gradient, anchoring and laying the geotextiles in rolls or grids, in the direction of water flow, trenching the bottom portions, placing the seedlings of required plant species with necessary fertilizer and irrigating the laid area. Rolls of the coir matting were first anchored firmly in the trench and then unrolled along the slope. A minimum overlap of 15 cm is given between adjacent ones. Anchoring of the matting was with mild steel staples spaced to form 2m grids. If the soil is organic, additional fertilizers are not necessary.

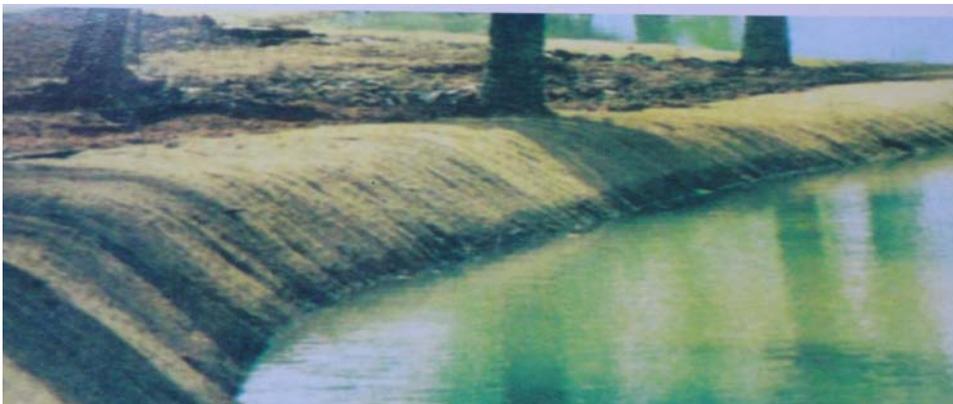
Thodu bund after growth of vegetation

Geotextiles give maximum protection to the soil beneath until the grass takes root and provide permanent vegetation. After the soil is thus stabilized, the netting decomposes and provides nourishment to the grass growing in the soil.
